Section 7	.....	
Inspection and Evaluation of Common Concrete Superstructures		
7.8	Prestressed Double Tees .....	7.8.1
7.8.1	Introduction .....	7.8.1
7.8.2	Design Characteristics .....	7.8.1
	General .....	7.8.1
	Primary Members and Secondary Members .....	7.8.3
	Steel Reinforcement .....	7.8.3
7.8.3	Overview of Common Defects .....	7.8.4
7.8.4	Inspection Procedures and Locations .....	7.8.4
	Procedures .....	7.8.4
	Visual .....	7.8.4
	Physical .....	7.8.4
	Advanced Inspection Techniques .....	7.8.5
	Locations .....	7.8.5
	Bearing Areas.....	7.8.5
	Shear Zones.....	7.8.6
	Tension Zones.....	7.8.6
	Secondary Members.....	7.8.6
	Areas Exposed to Drainage.....	7.8.6
	Areas Exposed to Traffic .....	7.8.7
	Areas Previously Repaired.....	7.8.7
	General.....	7.8.7
7.8.5	Evaluation.....	7.8.7
	NBI Rating Guidelines .....	7.8.7
	Element Level Condition State Assessment.....	7.8.7

# Topic 7.8 Prestressed Double Tees

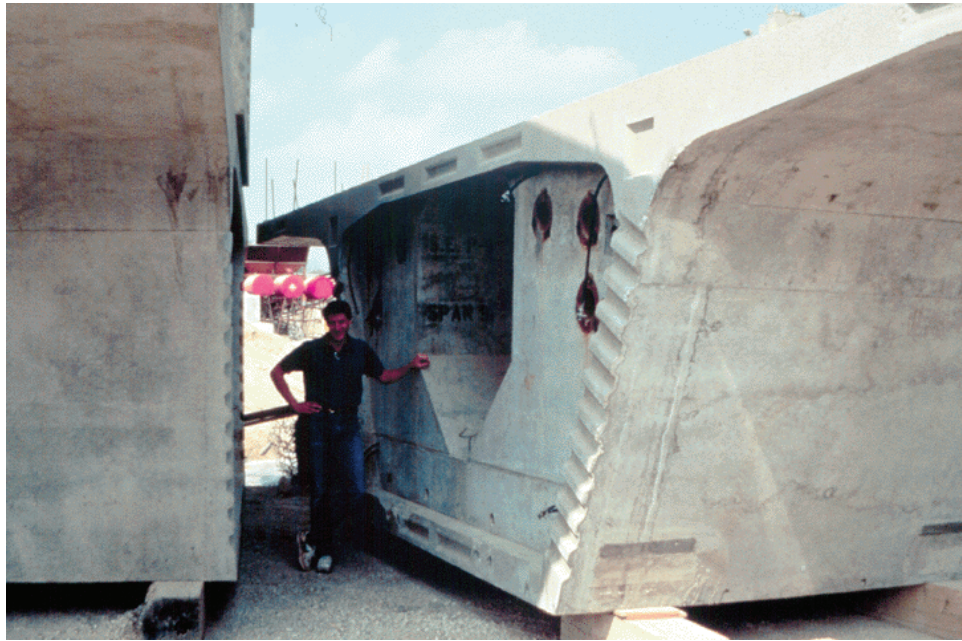
**Figure 7.11.43** Box Girder Interior (End) Diaphragm

Internal diaphragms at the piers and abutments serve to stiffen the box section and to distribute the large bearing reaction loads. Tendon anchorages located within the

diaphragm can also contribute to additional loads. This region of the structure is very highly stressed and, therefore, prone to crack development. The internal diaphragms require close examination during inspection (see Figure 7.11.43).

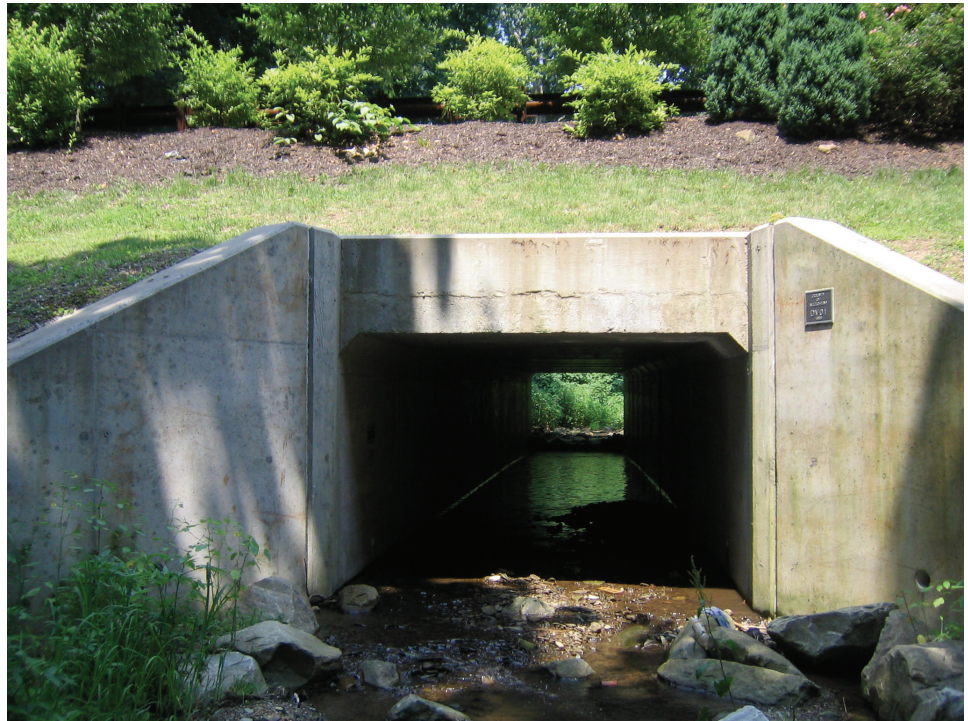
**Figure 7.12.1** Concrete Box Culvert

One of the most common types of culverts used today is the concrete box culvert (see Figure 7.12.1). A box culvert has an integral bottom slab that supports the side walls and provides a lined channel for the water to flow. The dimensions of the box culvert are determined by the peak flow of the channel. Box culverts are used in a variety of circumstances for both small and large channel openings and are easily adaptable to a wide range of site conditions, including sites that require low profile structures. In situations where the required size of the opening is very large, a multi-cell box culvert can be used (see Figure 7.12.2). It is important to note that although a box culvert may have multiple barrels, it is still a single structure. The internal walls are provided to reduce the unsupported length of the top slab.

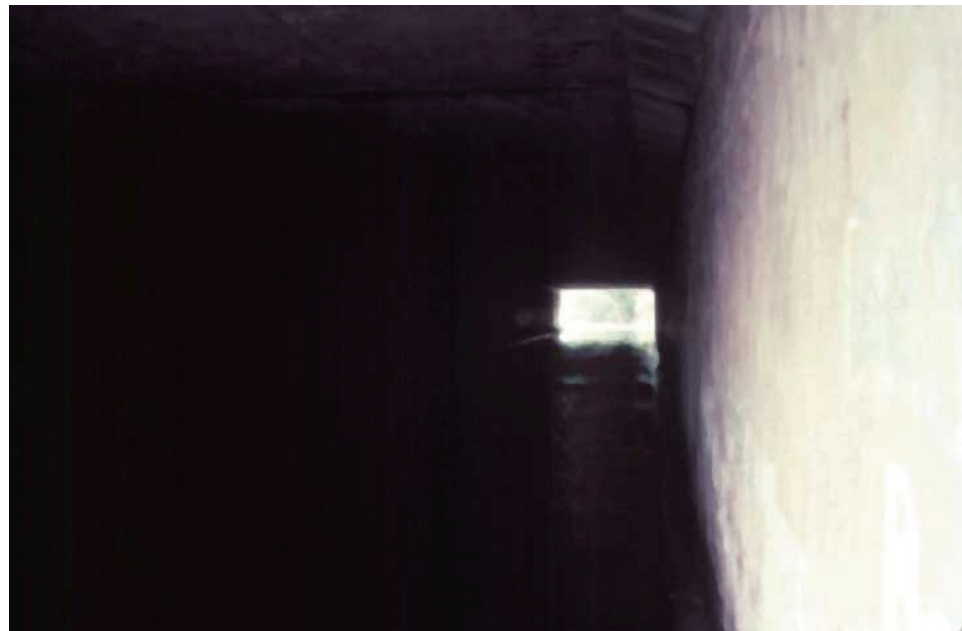
**Figure 7.12.7** Sighting Along Culvert Sidewall to Check Horizontal Alignment

The vertical and horizontal alignment should be checked by visual observation. Vertical alignment should be checked for sags or differential settlement at joints. Sags can best be detected during low flows by looking for areas where the water is deeper or where sediment has been deposited. When excessive accumulations of sediment are present, it may be necessary to have the sediment removed before checking for sags. An alternate method would be to take profile elevations of the top slab. The horizontal alignment can be checked by sighting along the walls and by examining joints for differential movement (see Figure 7.12.7).

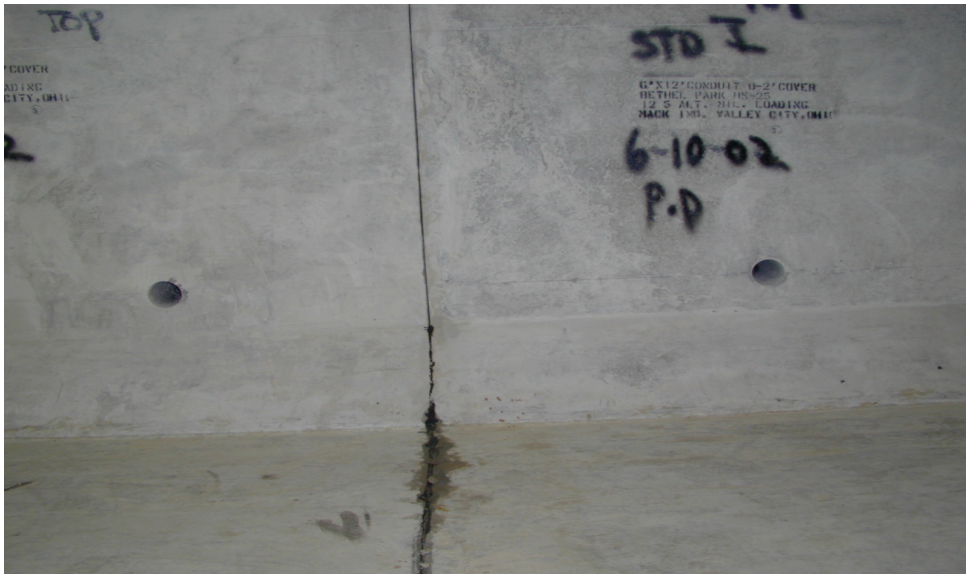
**Figure 7.12.8** Precast Concrete Box Culvert Joint

Expansion joints should be carefully inspected to verify that the filler material or joint sealant is in place and that the joint is not filled with incompressible material that would prohibit expansion (see figure 7.12.8). Spalls or cracks along joint edges are usually an indication that the expansion joint is full of incompressible materials or that one or more expansion joints are not working. Joint inspection also should identify any joints that are opened widely or are not open to uniform width. Water flowing or seeping into the culvert through open joints (infiltration) may bring with it supporting soil. Water flowing out of the culvert through open joints (exfiltration) may cause loss of supporting material.

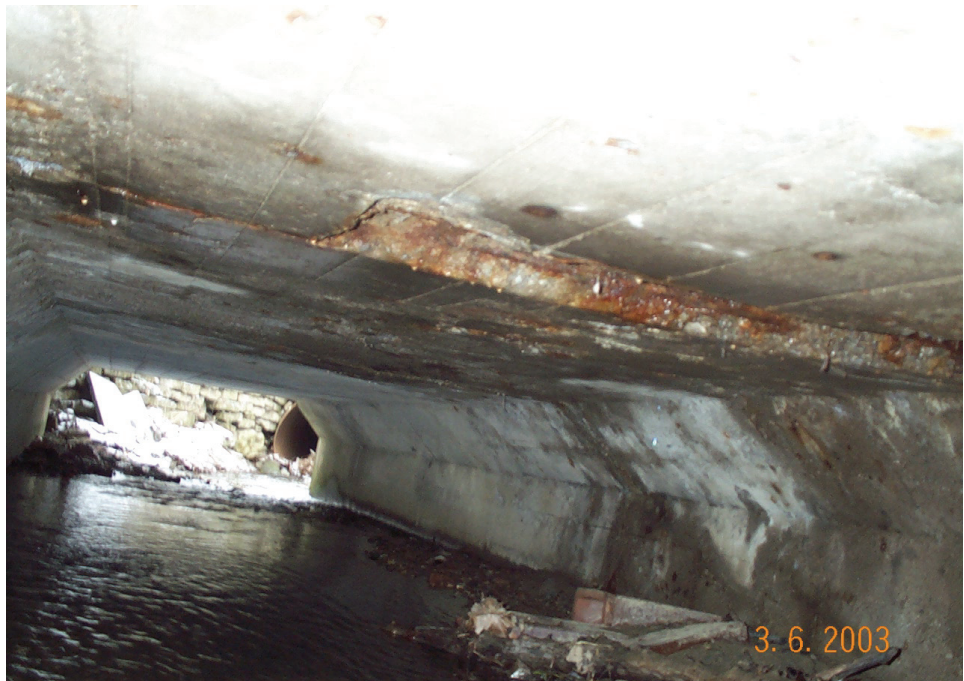
**Figure 7.12.10** Spalls and Delaminations

The top slab and walls should be inspected visually for cracks and spalls. When either is observed, the area around the defect should be tapped with a hammer to detect delaminations. A ladder may be needed for inspecting the top slab. Longitudinal cracks (along the length of the culvert) in the top slab of box culverts may indicate either flexure or shear problems. Transverse cracks may indicate differential settlement. Longitudinal cracks may also indicate differential wall settlement, or structural overloading. Transverse cracks in the top slab (perpendicular to walls) indicate differential settlement of the culvert. Spalls may occur along the edges of cracks or in the concrete covering corroded reinforcing steel. Cracks in the sides may be caused by settlement or earth pressure. The location, width, and length of all cracks and spalls should be noted in the inspection report as well as crack spacing.
